DEVELOPMENT OF NEW PEDESTRIAN CROSSING GUIDELINES IN UTAH

Final Report

Utah Department of Transportation Research and
Development Division

Department of Civil and Environmental Engineering
University of Utah

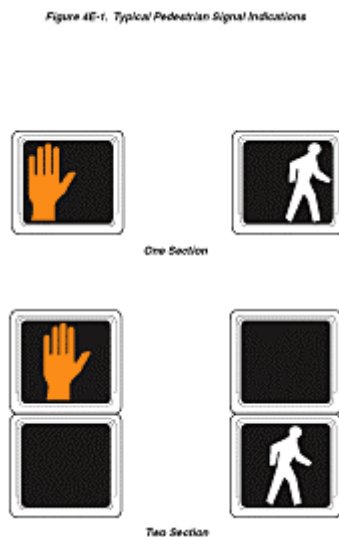
Figure 4E-1 Typical Pedestrian Signal Indications

All new pedestrian signal head indications shall be displayed within a rectangular background and shall consist of symbolized messages (see Figure 4E-1), except that existing pedestrian signal head indications with lettered or outline style symbol messages may be retained for the remainder of their useful service life. The symbol designs that are set forth in the "Standard Highway Signs" book shall be used. Each pedestrian signal head indication shall be independently illuminated and emit a single color.

The UPRAISED HAND (symbolizing DONT WALK) signal section shall be mounted directly above or integral with the WALKING PERSON (symbolizing WALK) signal section.

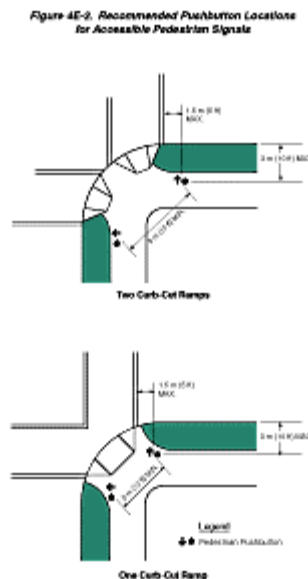
Figure 4E-2 Recommended Pushbutton Locations for Accessible Pedestrian Signals

- A. Adjacent to a level all-weather surface to provide access from a wheelchair, and where there is an all-weather surface, wheelchair accessible route to the ramp;
- B. Within 1.5 m (5 ft) of the crosswalk extended;
- C. Within 3 m (10 ft) of the edge of the curb, shoulder, or pavement; and
- D. Parallel to the crosswalk to be used.

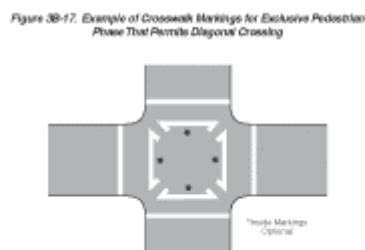
[Figure 3B-17](#) Example of Crosswalk Markings for Exclusive Pedestrian Phase That Permits Diagonal Crossing

When an exclusive pedestrian phase that permits diagonal crossing is provided at a traffic control signal, a marking as shown in Figure 3B-17 may be used for the crosswalk.

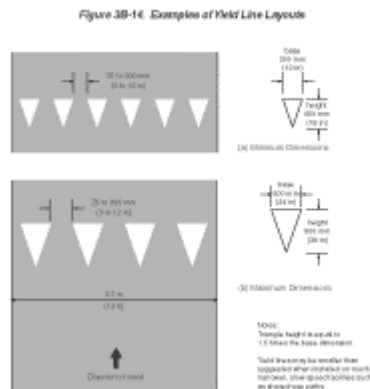
[Figure 3B-14](#) Examples of Yield Line Layouts

If used, yield lines (see Figure 3B-14) shall consist of a row of solid white isosceles triangles pointing toward approaching vehicles extending across approach lanes to indicate the point at which the yield is intended or required to be made.

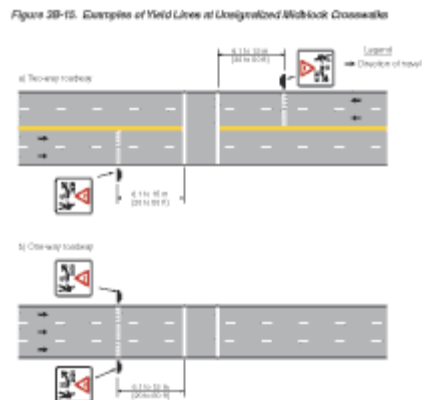
Figure 3B-15 Examples of Yield Lines at Unsignalized Midblock Crosswalks

If used at an unsignalized midblock crosswalk, yield lines should be placed adjacent to the Yield Here to Pedestrians sign located 6.1 to 15 m (20 to 50 ft) in advance of the nearest crosswalk line, and parking should be prohibited in the area between the yield line and the crosswalk (see Figure 3B-15).

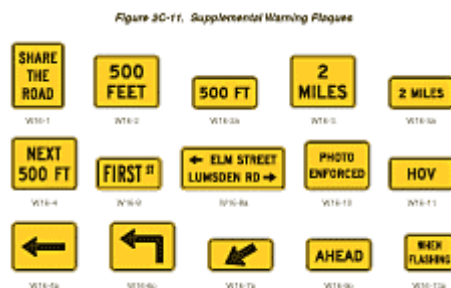
Figure 2C-11 Supplemental Warning Plaques

When used at the crossing, Nonvehicular signs shall be supplemented with a diagonal downward pointing arrow (W16-7p) plaque (see Figure 2C-11) showing the location of the crossing.

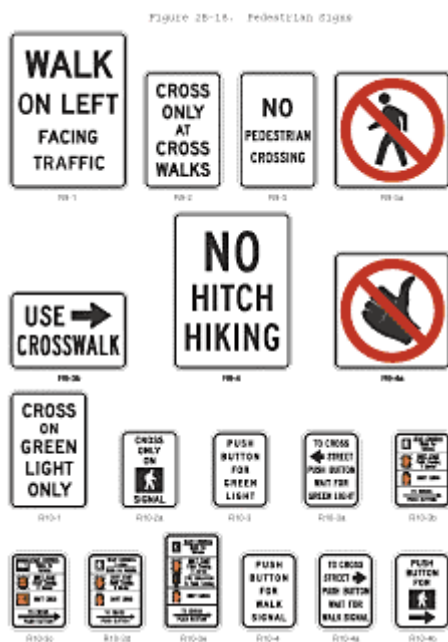
[Figure 2B-18](#) Pedestrian Signs

The No Hitchhiking (R9-4a) sign (see Figure 2B-18) may be used to prohibit standing in or adjacent to the roadway for the purpose of soliciting a ride. The R9-4 word message sign (see Figure 2B-18) may be used as an alternate to the R9-4a symbol sign.

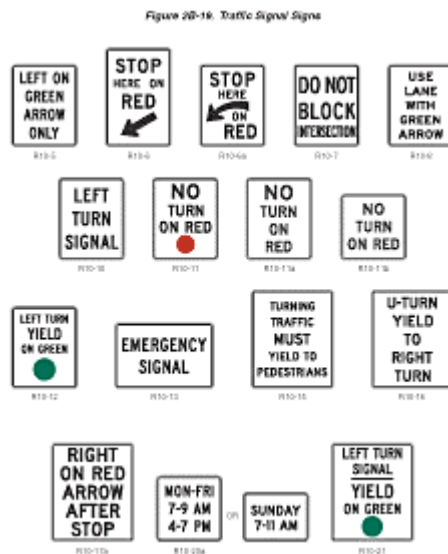
[Figure 2B-19](#) Traffic Signal Signs

In order to remind drivers who are making turns to yield to pedestrians, especially at intersections where right turn on red is permitted and pedestrian crosswalks are marked, a TURNING TRAFFIC MUST YIELD TO PEDESTRIANS (R10-15) sign may be used (see Figure 2B-19).

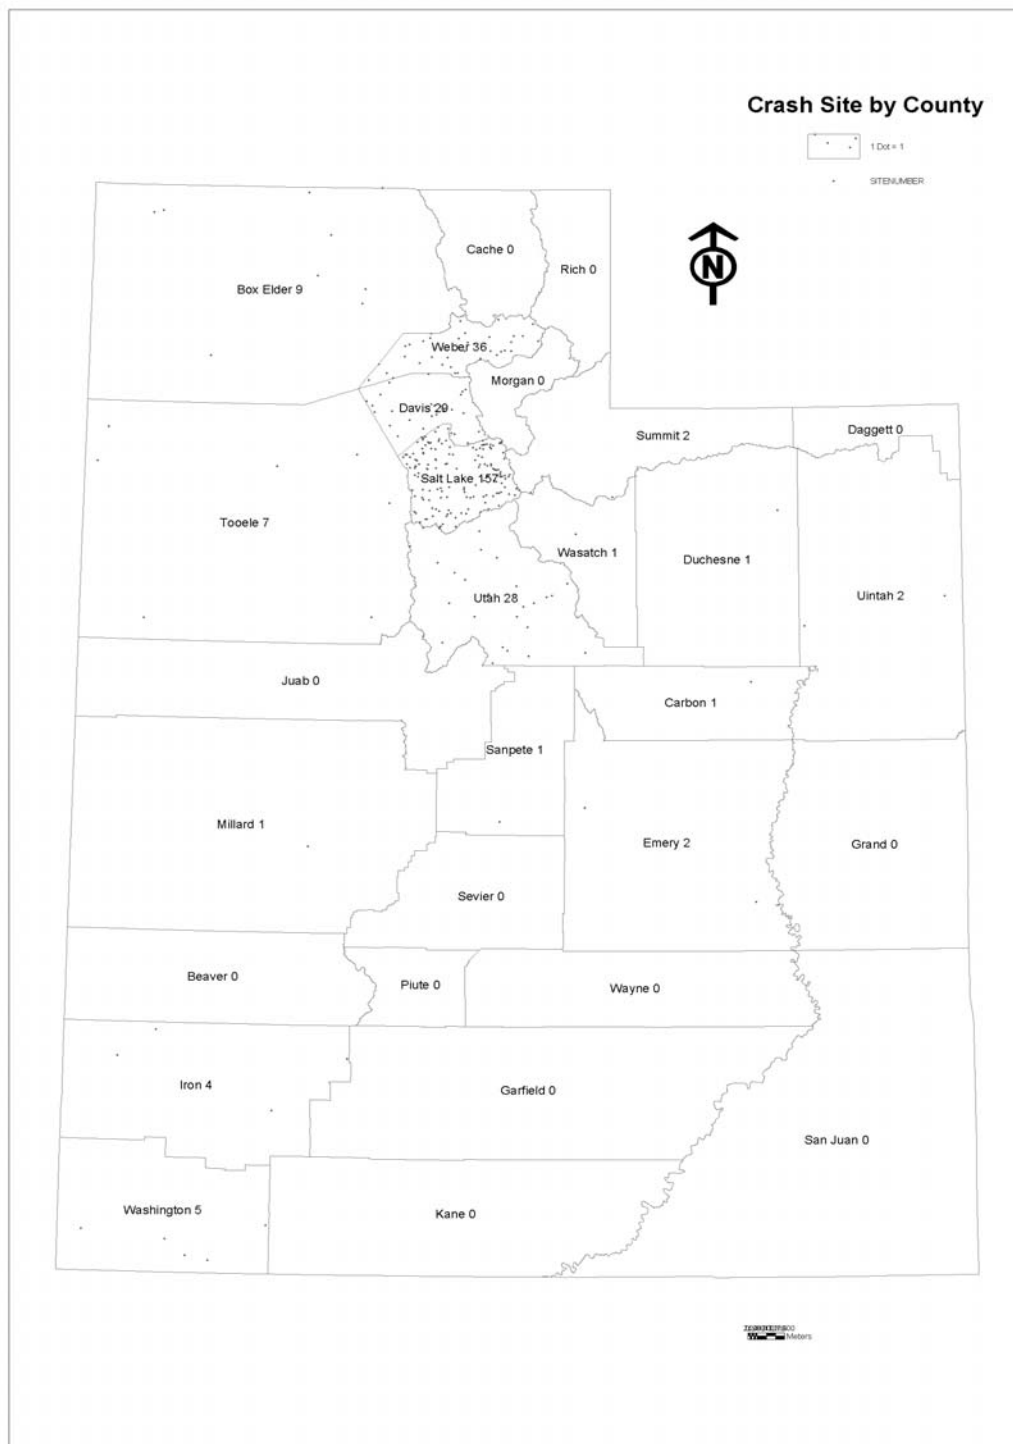
Figure 2. General Locations of Sampled Pedestrian-Vehicle Crash Sites

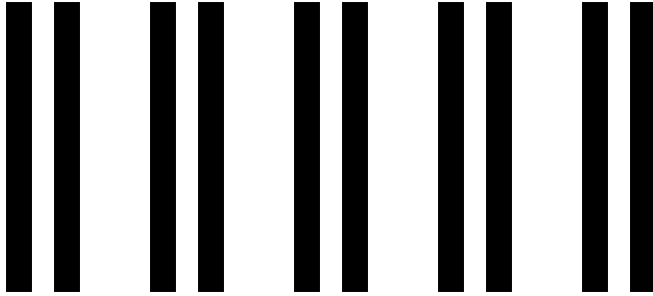
Figure 3. Non-Symmetrical Piano Key Crosswalk Layout

(Note: Each piano key is 8 ft in length; each pair is spaced at 4 ft center-to-center; within each pair, the keys are spaced at 2 ft. The width of each key is 8 in. The markings would actually be white in practice; black is used here to provide contrast.)

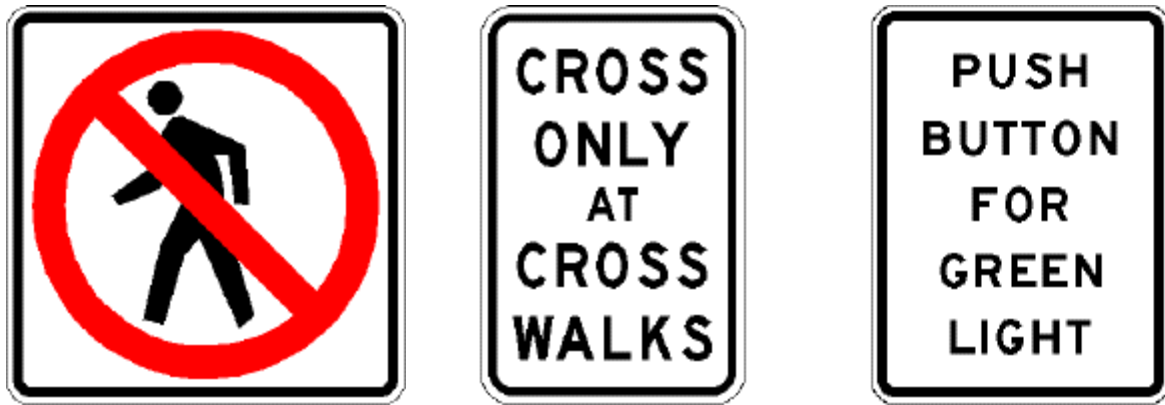
Figure 4. Example Regulatory Signs Directed at Pedestrians (R9-3a, R9-2, R10-3)
